16.0 Shiprock, New Mexico, Disposal Site

16.1 Compliance Summary

16.3.1 Annual Inspection and Report

Figure 16-1. 2003 Annual Compliance Drawing for the Shiprock, New Mexico, Disposal Site

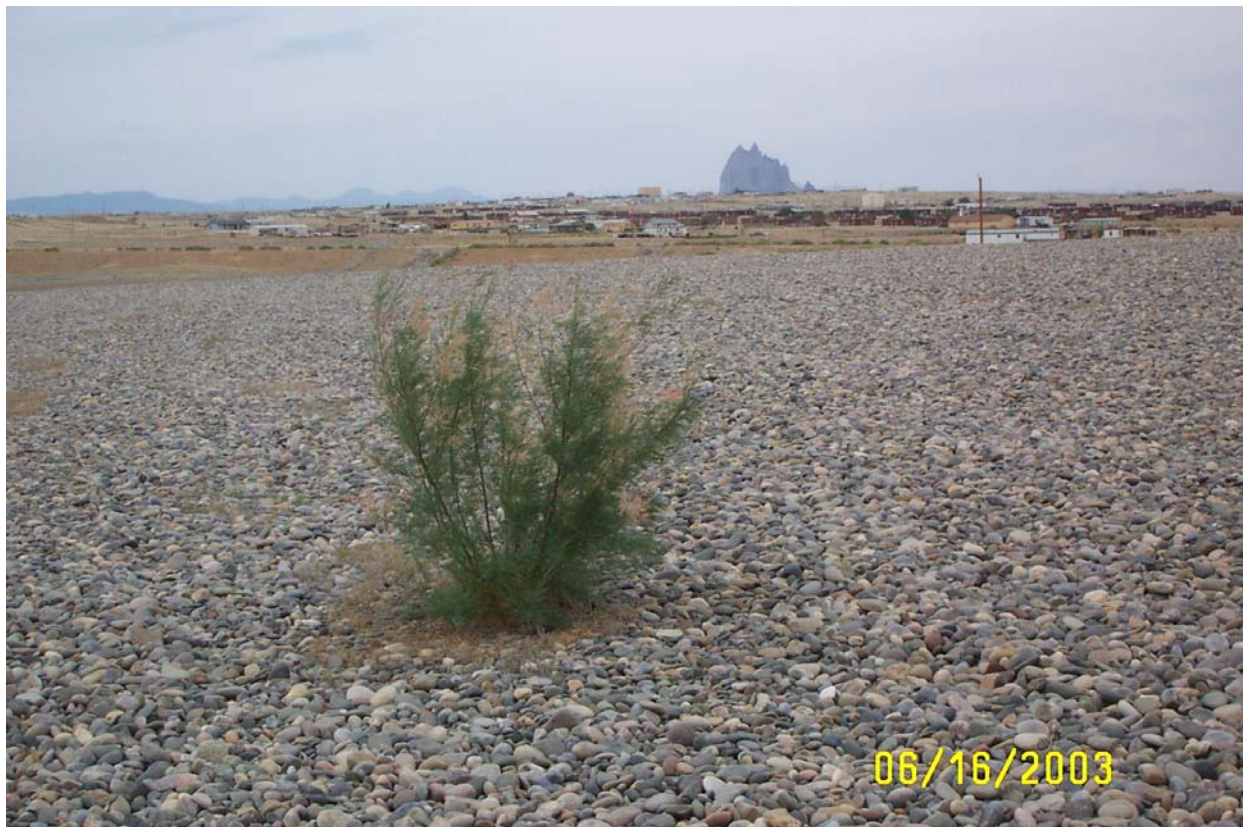
16C Significant vegetation growth has been noted during past inspections on the cell top and the east, northeast, and northwest side slopes. These areas were sprayed in June 2001 in a continuing effort to reduce the seed source and control future plant encroachment on the disposal cell. Numerous patches of annual grasses and weeds were present on the cell top and the side slopes in 2003. Several deep-rooted woody shrubs were found on the cell top and were cut and treated with herbicide (PL-1). The population of woody shrubs growing on the cell side slopes continues to increase. The DOE will continue to monitor and control vegetation growth to maintain the performance of the cell.

SHP 6/2003. PL–1. Tamarisk on the cell top before being cut and treated with herbicide.

In 2003, DOE reconstructed the outflow channel, repaired a damaged fence, replaced a missing boundary monument, removed deep-rooted plants from the cell top, and cleared windblown weeds, trash, and sand from fences.

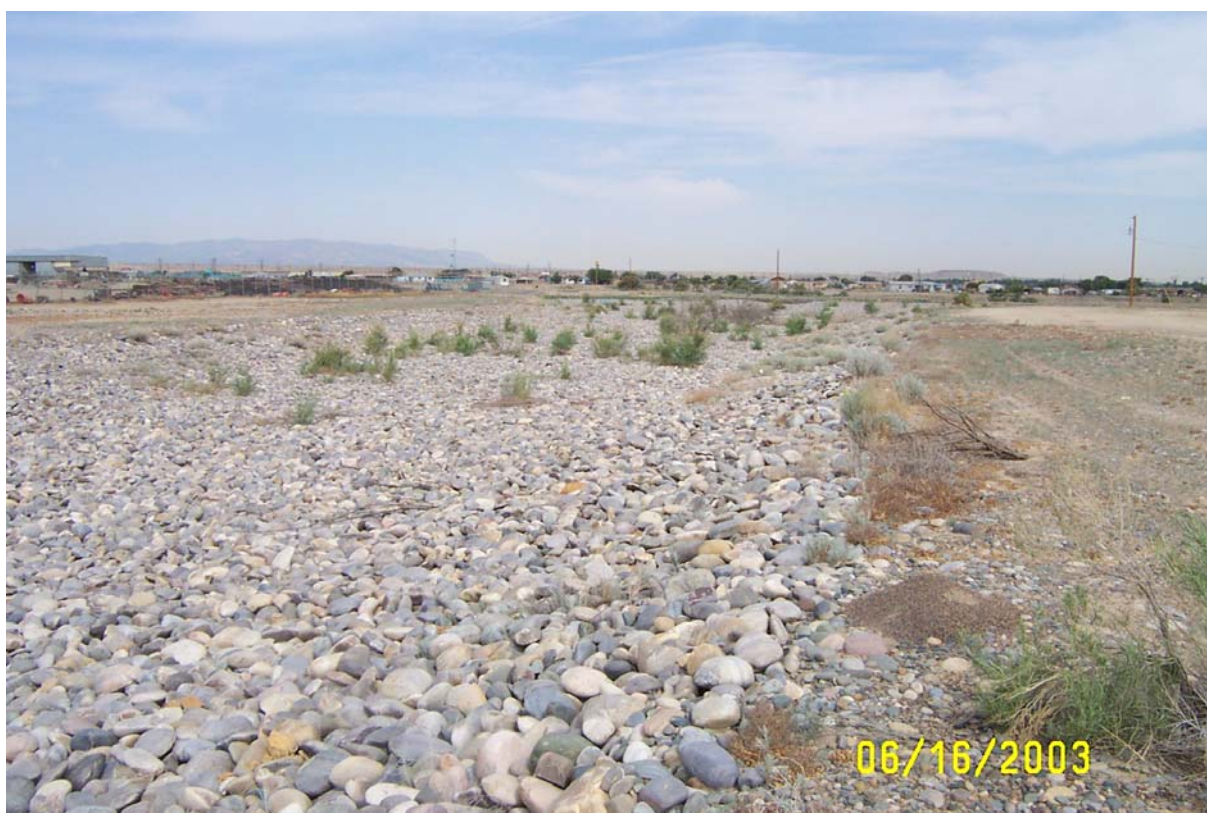
Diversion channels around the base of the disposal cell were in good condition. Site drainage is ultimately directed toward the outflow channel at the northwest corner of the site. Rock cover in the outflow channel was in good condition. Vegetation is increasing in the diversion and outflow channels (PL-2); however, the performance of the channels is not impaired.

SHP 6/2003. PL-2. Vegetation in the outflow channel.

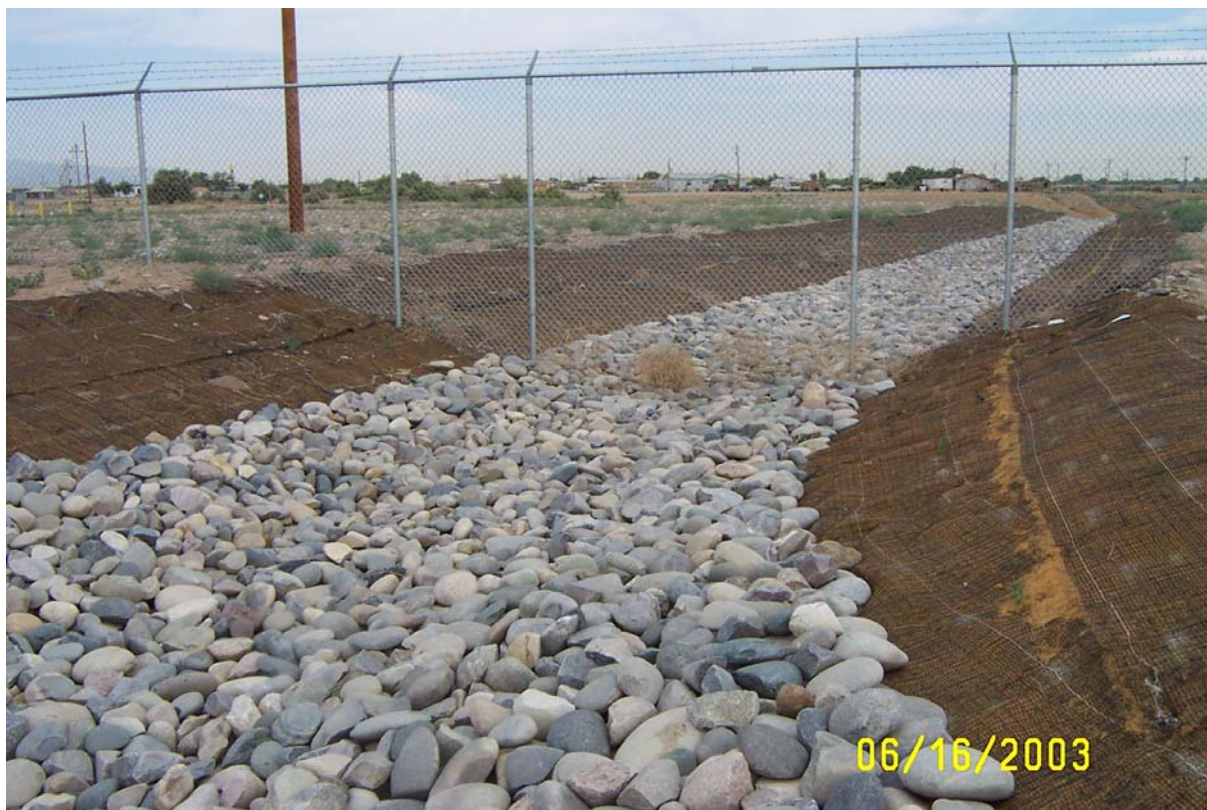
16D Erosion damage downstream of the riprap-armored outflow channel was repaired in winter 2003. The outflow channel was extended to Bob Lee Wash and was lined with rock-filled gabions (PL-3). A gabion-lined energy dissipation basin was constructed at the confluence with Bob Lee Wash (PL-4). Additionally, the west side of the wash downstream of the outflow channel was reinforced with gabions to prevent erosion of an access road.

SHP 6/2003. PL-3. Reconstructed outflow channel where it exits the property.

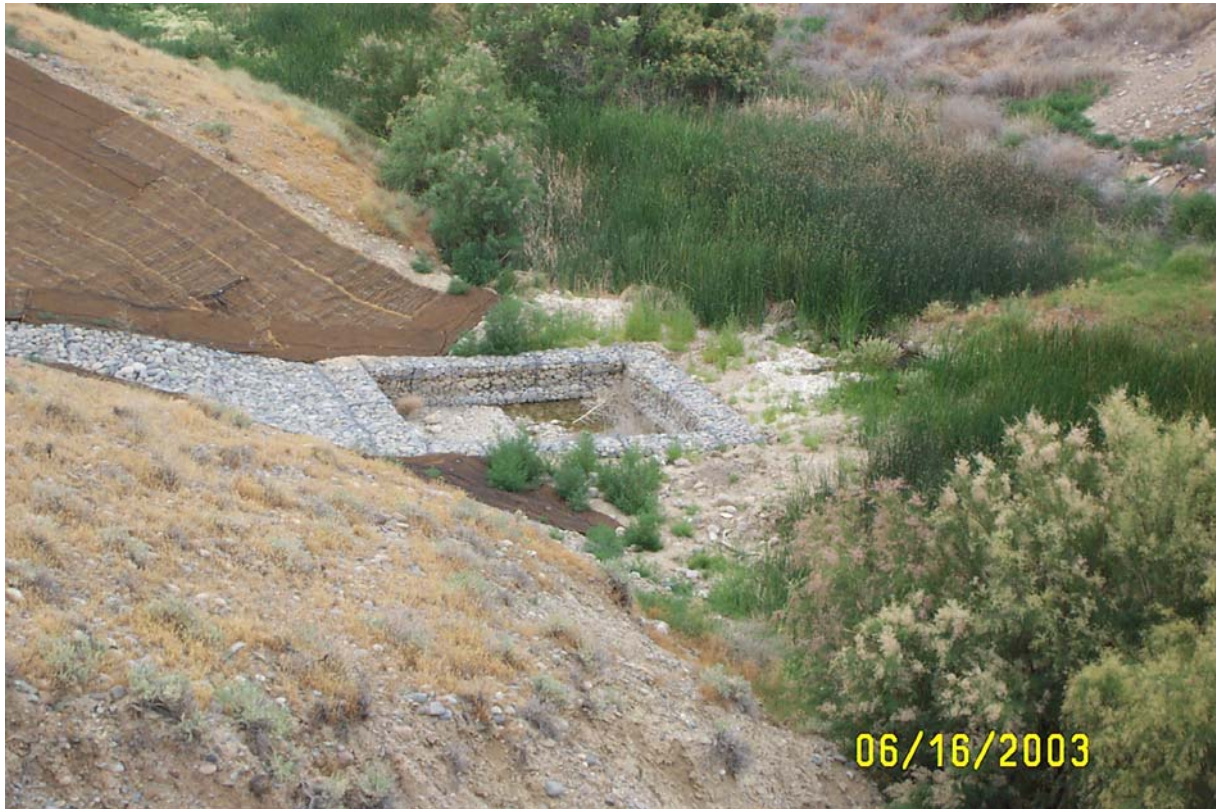
SHP 6/2003. PL-4. Energy dissipation basin at the mouth of the outflow channel in Bob Lee Wash.
